**INTERSECTION EVALUATION
GILLOTTI ROAD AT HIGH SCHOOL/
MIDDLE SCHOOL DRIVEWAY
NEW FAIRFIELD, CT**

MMI #3101-02

August 21, 2008

***Prepared for:
Housatonic Valley Council of Elected Officials***

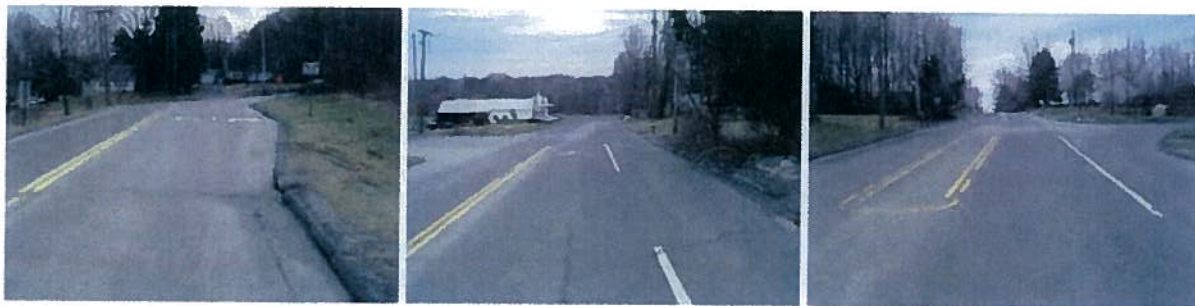
School Driveway approach to Gillotti Rd.

Gillotti Rd Eastbound approach to School Driveway

Gillotti Rd Westbound approach to School Driveway

The horizontal alignment of Gillotti Road at the school is generally good, although the introduction of a left turn lane both narrows and shifts the eastbound through lane as it passes the school driveway. Sight lines from the school driveway are approximately 365 feet to the west and around 395 feet to the east. The posted speed limit in the area is 25 miles per hour, although the 85th percentile speed of vehicles traveling in both directions on this roadway is about 42 miles per hour. The 85th percentile is defined as the speed at or below which 85 percent of the traffic travels. Given a prevailing travel speed of 42 miles per hour, the minimum sight line distance criteria set by the Connecticut Department of Transportation (ConnDOT) is 463 feet. Based on this value, the sight line distance adequate in both directions for the posted speed limit; however it is inadequate for the 85th percentile speeds.

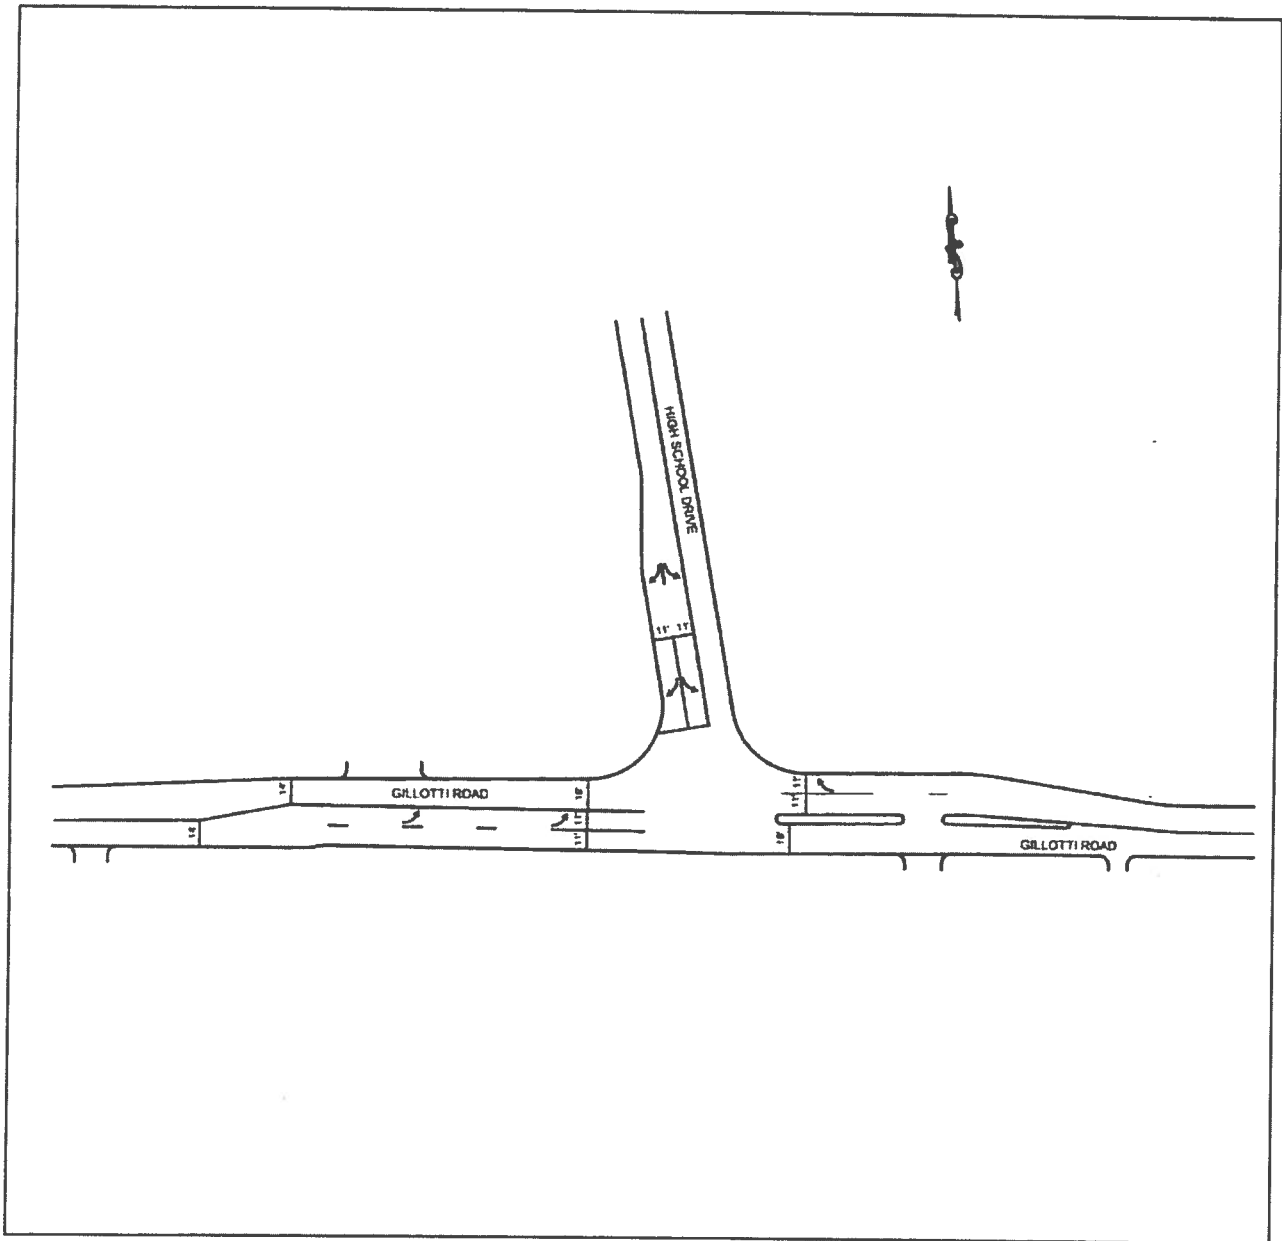
INTERSECTION LAYOUT

The school driveway is approximately 36 feet wide at its intersection with Gillotti Road; it features two lanes for exiting traffic and one lane for entering traffic. About 100 feet to the north, the driveway tapers to about 27 feet wide with two lanes and is striped with a single yellow line. Curbs and overhead lighting are present. A general layout of the intersection is shown in Figure 2.

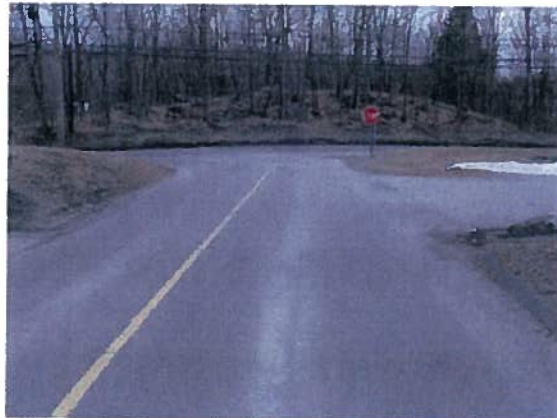
Beaver Bog Road is approximately 21 feet wide at its intersection with Route 37; it features single lanes for approach and departure traffic. Approximately 65 feet from Route 37 along the west side of Beaver Bog Road exists a driveway for the aforementioned church. Beaver Bog Road is marked with a single yellow centerline. The Stop sign and Stop line are located approximately 30 feet back from the edge of Route 37, which is to allow adequate spacing for trucks turning left into Beaver Bog Road. Overhead lighting is present; however, curbs are not.

Beaver Bog Road approach to Route 37

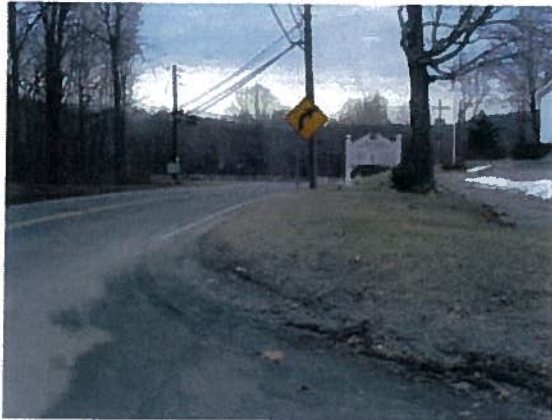
The horizontal and vertical alignment of Route 37 limits the sight distance to the west from Beaver Bog Road. To compound the issue, the New Life Community Church parking lot is supported by a berm of earth that falls directly within the sight line. The existing sight line is approximately 225 feet. The sight line looking to the east from Beaver Bog Road is greater than 600 feet. It should be noted that the sight lines to the east were recorded during winter months, and could be shorter during summer months with potential vegetation growth. Given a prevailing travel speed of 40 miles per hour, the minimum sight line distance criteria set by the Connecticut Department of Transportation (ConnDOT) is 445 feet. Based on this value, the sight line distance to the west is inadequate for the posted speed limit and the 85th percentile speed.

Looking west from Beaver Bog Road

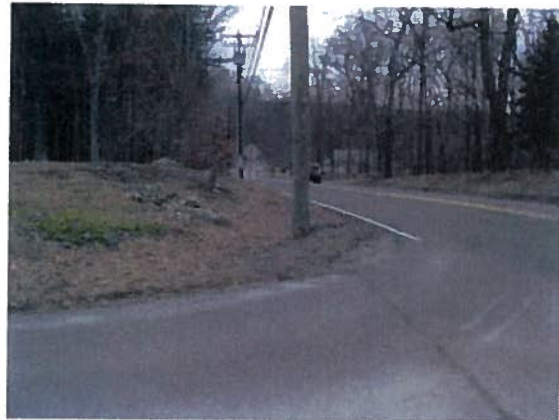
Looking east from Beaver Bog Road

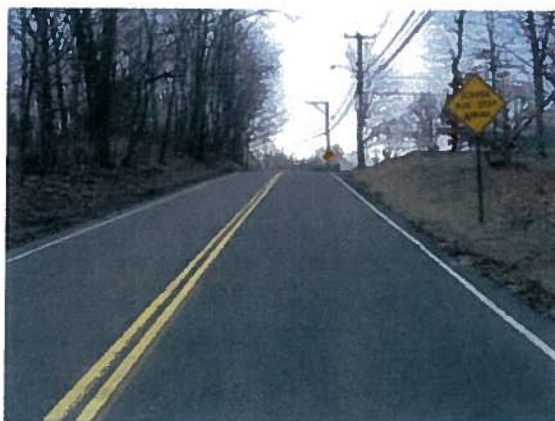
Route 37 westbound approach to Beaver Bog Road

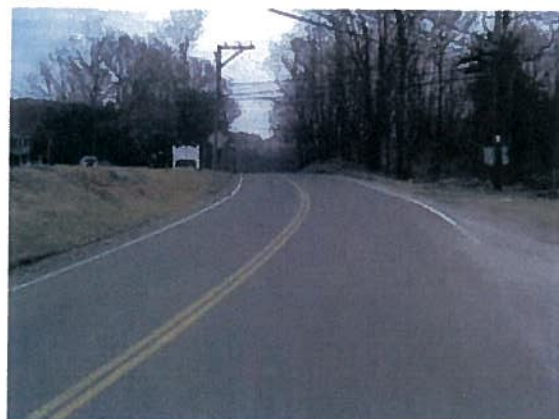
In addition to visibility concerns for motorists exiting the site, the stopping sight distance for eastbound vehicles on Route 37 is insufficient. Based on a 40 mile per hour 85th percentile speed, ConnDOT guidelines recommend a stopping sight distance of approximately 330 feet. The eastbound stopping sight distance is approximately 230 feet, approximately 100 feet shorter than stated in the guidelines. An oversized, advanced warning sign posted for eastbound motorists indicating the approaching roadway curvature and the Beaver Bog Road intersection.

Route 37 eastbound approach to Beaver Bog Road
