**INTERSECTION EVALUATION
GILLOTTI ROAD AT HIGH SCHOOL/
MIDDLE SCHOOL DRIVEWAY
NEW FAIRFIELD, CT**

MMI #3101-02

August 21, 2008

***Prepared for:
Housatonic Valley Council of Elected Officials***

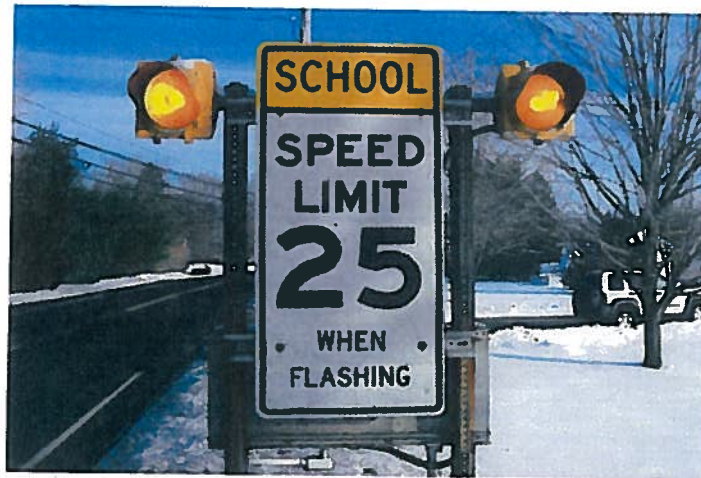
Photo 1 – Typical Flashing School Speed Limit Sign

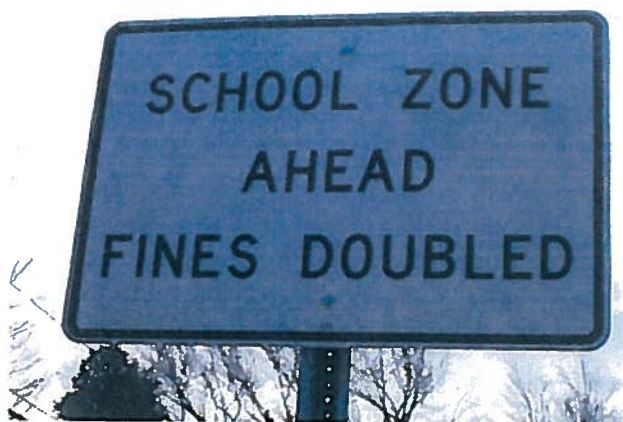
best be paired with an appropriate level of enforcement and would likely be the best candidate since the posted speed limit is already 25 mph. An example of this sign is shown in Photo 2.

Photo 2 – Typical School Zone Ahead Fines Doubled
