10.0 COPPS HILL/FARMINGVILLE ROADS TO ROUTE 7

10.1 Existing Conditions

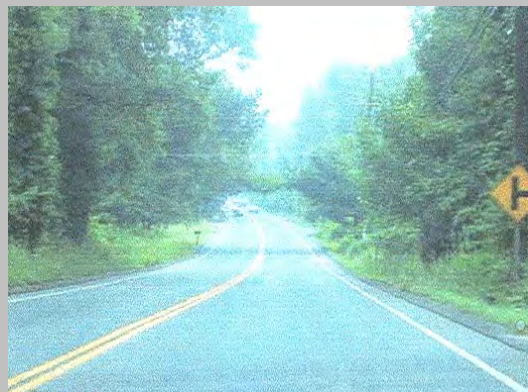
Route 35 north of Copps Hill Road/Farmingville Road looking north

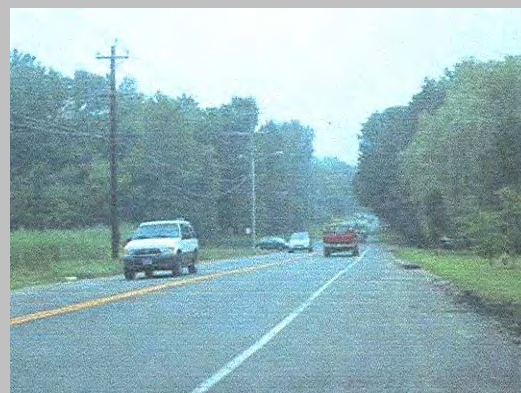
Route 35 between Copps Hill Road and Route 7 with striped shoulders approximately 6 feet wide

Route 35 in this section has several horizontal and vertical curves with shoulder widths ranging from 1 to 6 feet. The most common features in this section are low stonewalls and mature landscaping.
